## Electrical services at Gloucester's Energy from Waste Plant

In the summer of 2016 PTSG completed the full lightning protection and earthing installation works at the Severnside Energy Recovery Centre (SERC) in Avonmouth, working alongside VVB Engineering and Sir Robert McAlpine.

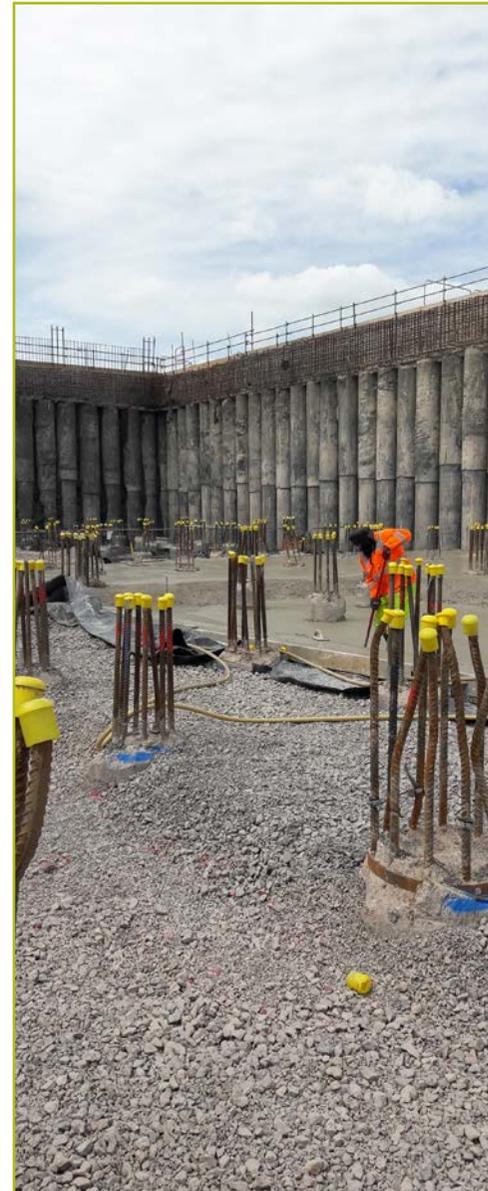
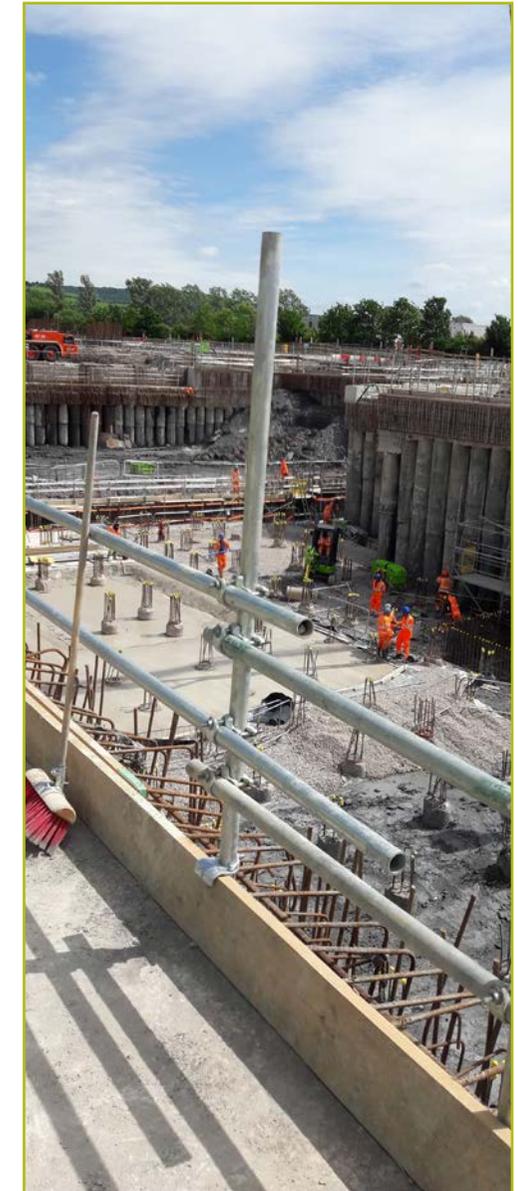
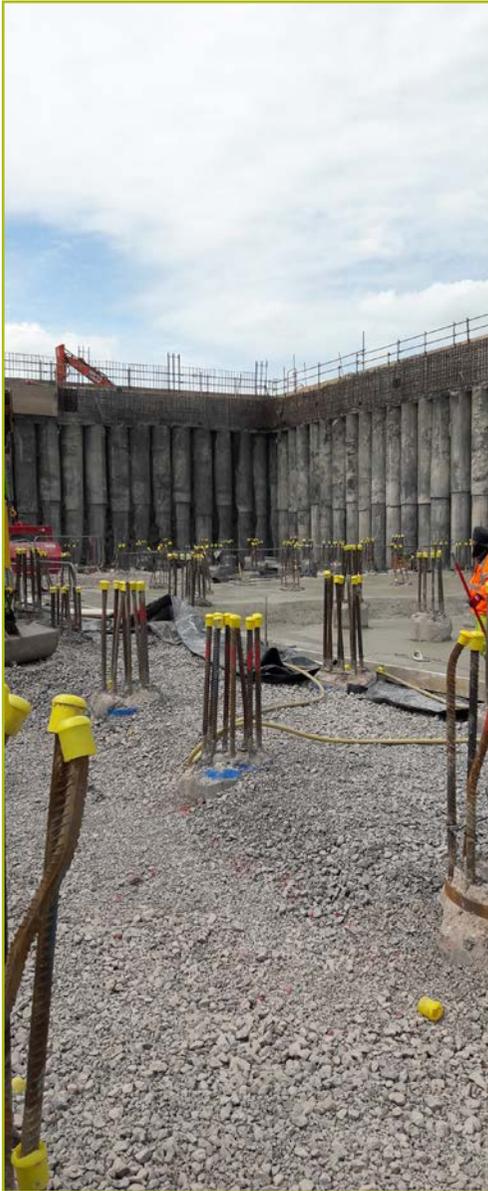
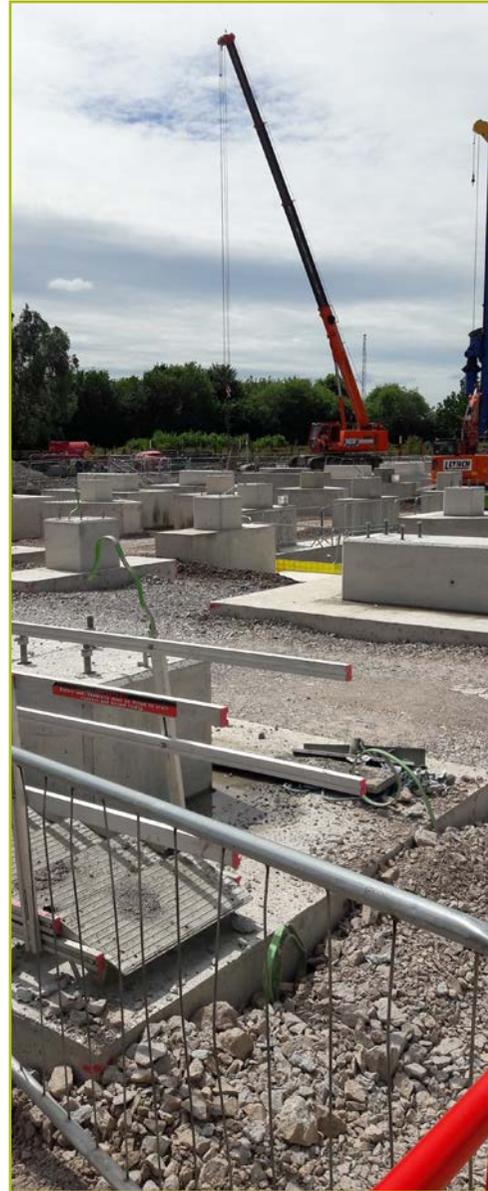
**The buried copper ring conductor was exothermically welded throughout all areas.**

At the ground level and basement levels we utilised over 100 structural pile foundations as part of the overall earthing system. These were tested in isolation prior to connecting onto the ring beam, with copper tape connections being made onto the reinforcing bars prior to the concrete being poured. From these piles there were connections coming out to be extended up through the pile cage onto the main structural columns and also copper tape connections coming out sideways to the external buried copper ring conductor which also formed part of the overall earthing solution.

The buried copper ring conductor was exothermically welded throughout all areas, which involved a lot of input from all parties to ensure the hot works were done safely and correctly. Given the complexity of the design and the amount of connections that were being welded onto the ring tape, there were hundreds of welds that were all built into the overall programme and documented throughout.
